POTOMAC RIVER BASIN
CARBAUGH RUN DAM
SOUTH MOUNTAIN RESTORATION CENTER
NDI NO. PA-00881
DER NO. I-077
ADAMS COUNTY, PENNSYLVANIA
PHASE I INSPECTION REPORT
NATIONAL DAM INSPECTION PROGRAM

PHASE I REPORT
NATIONAL DAM INSPECTION PROGRAM

Name of Dam: CARBAUGH RUN DAM
State & State No.: PENNSYLVANIA, 1-077
County: ADAMS
Stream: CARBAUGH RUN
Date of Inspection: October 10, 1980

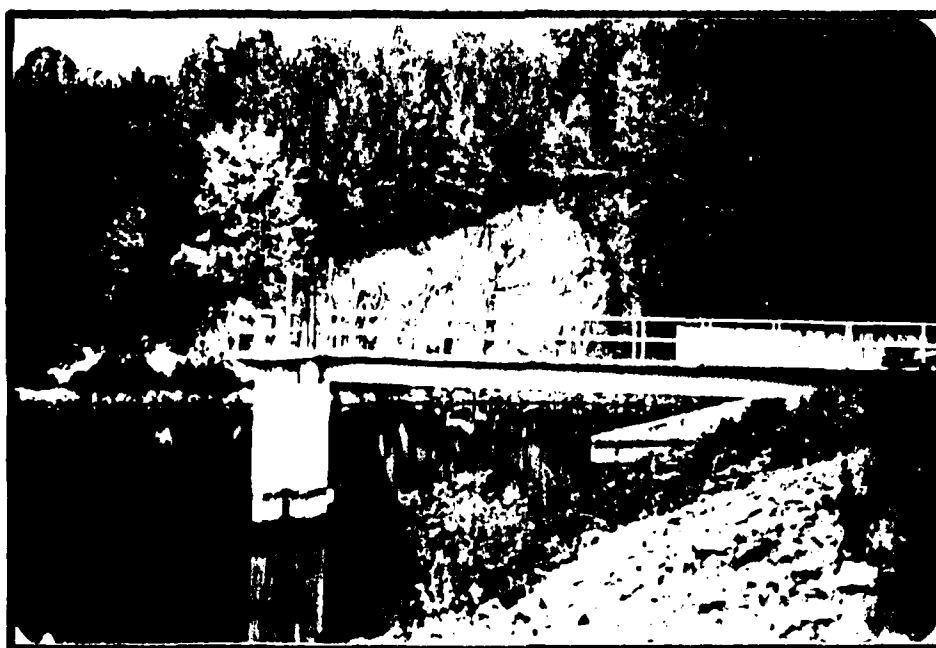
The intake control tower (Photograph No. 3) is located close to the spillway forebay area at the upstream toe. There are three gate operator stands on the platform. One gate controls the flow through the 60-inch diameter outlet pipe. This 24-inch gate is generally slightly open to meet the minimum downstream flow criteria. The other two gates control the water supply intake. The tower appears to be in good condition with a slight deterioration of the concrete at the normal pool level. Access to the tower is by a footbridge from the crest of the dam. A 2.5-inch displacement was noticed at the bearing of the bridge at the abutment. This condition is not considered serious. The abutment is constructed on the fill and it is possible that the abutment has moved. The 60-inch diameter outlet pipe terminates in the stilling basin.

Visual inspection of the intake control tower did not detect signs of structural instability. Although the footbridge has moved in relation to the abutment, this movement is probably caused by movement of the abutment in the fill. It apparently has stabilized and is not considered to be a serious problem.

INTAKE TOWER & FOOTBRIDGE - NO. 3

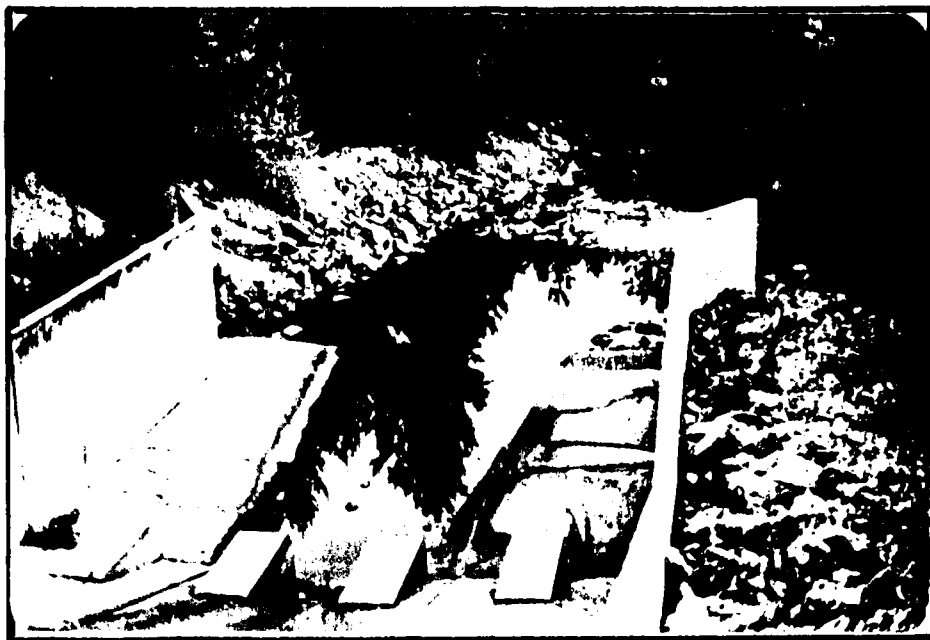
STILLING BASIN - NO. 8

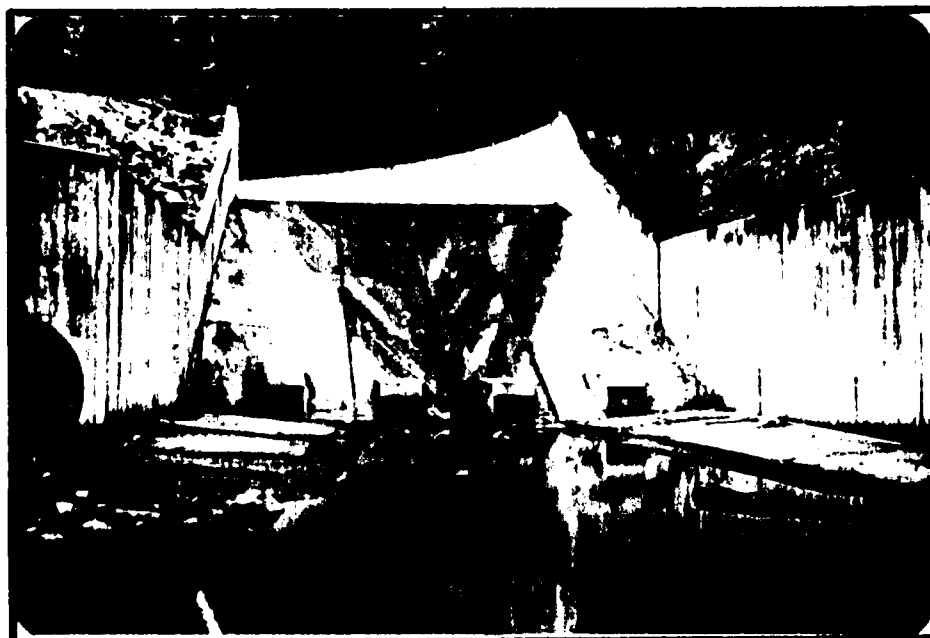
SPILLWAY CHUTE & STILLING BASIN - NO. 9
